FuelSpec® Combustion Catalysts

Case Study

Application of FuelSpec® 114-05 on ULSD 2007 Volvo Tractor with Cummins ISX 400 ST Engine

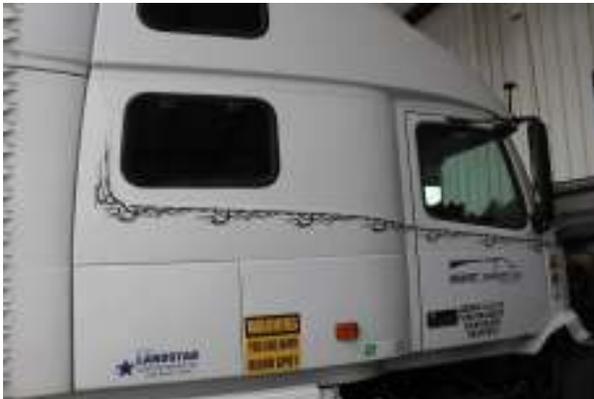
Picture 1

The truck had about 675,000 miles on it at the time of this inspection.

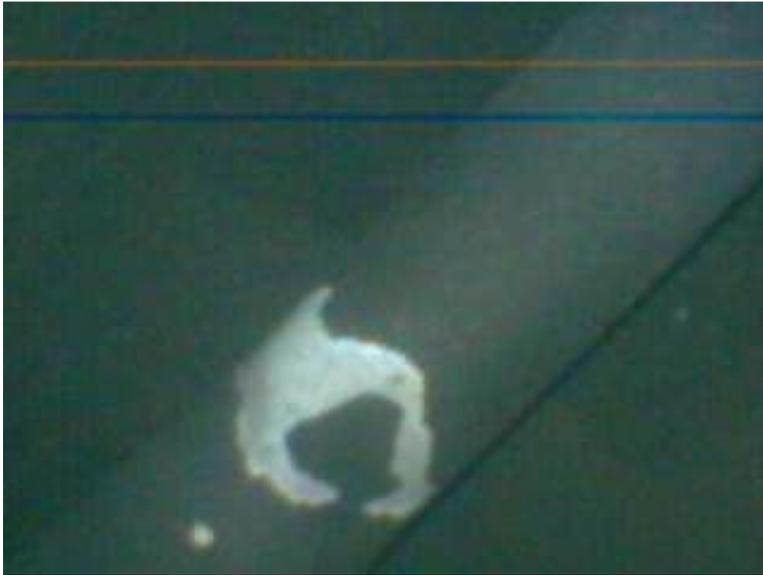
Picture 6 – top of exhaust valve stem, Truck 2

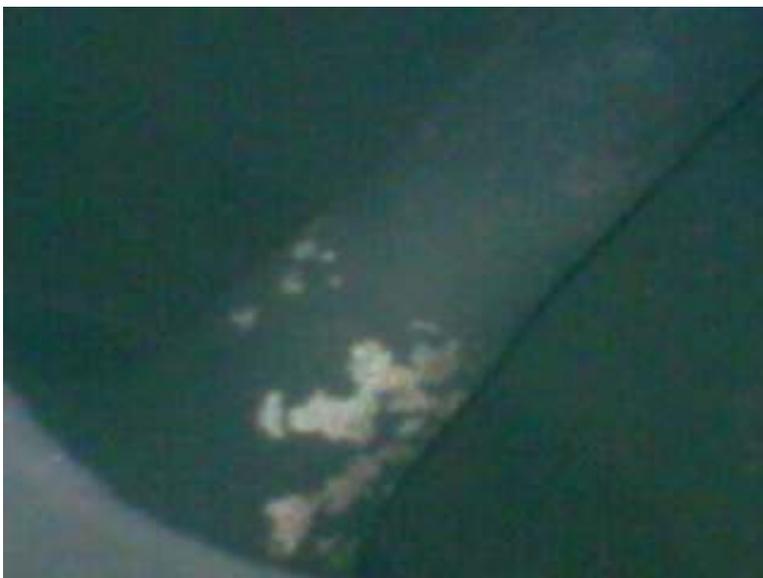
Picture 7 – bottom of exhaust valve stem, Truck 2
