FuelSpec® Combustion Catalysts

Case Study

Application of FuelSpec® 114-05 on ULSD 2007 Volvo Tractor with Cummins ISX 400 ST Engine

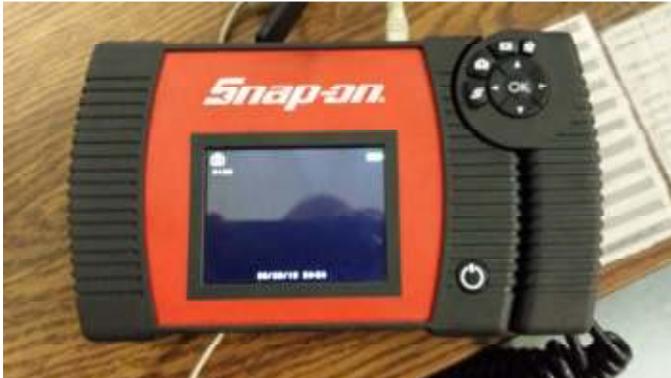
Picture 2

The tractor's exhaust side was opened and a borescope (**Picture 2**, below) was used to inspect the exhaust spaces.
